Research Paper

Mechanical assessment of grit blasting surface treatments of dental implants

K. Shemtov-Yona*, D. Rittel, A. Dorogoy

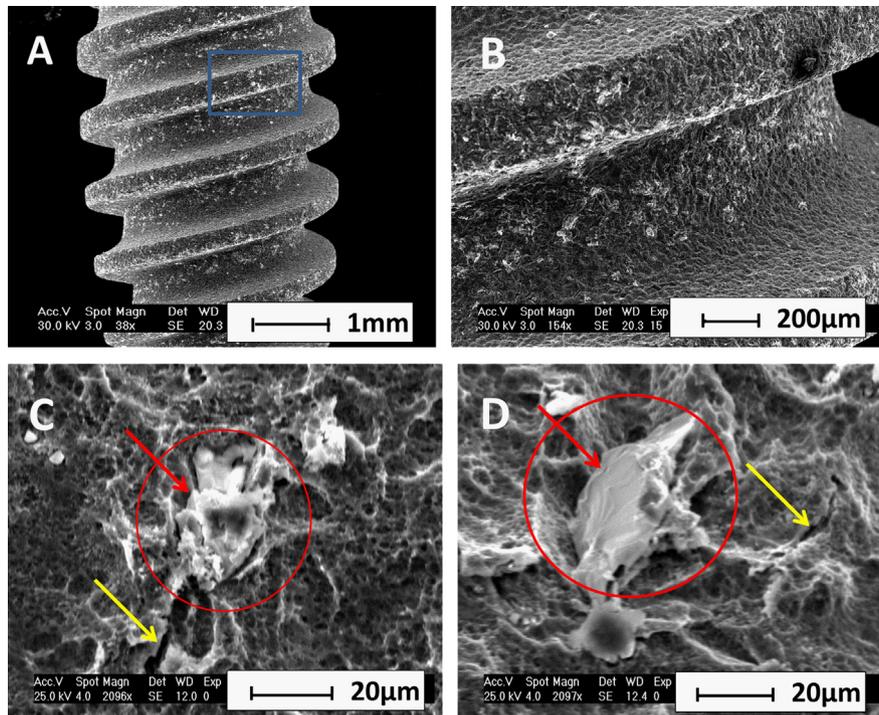
At small magnification (Fig. 4A), one can note that the implant's surface is rough, as expected for improved osseointegration. However, large areas are covered by small white particles. Fig. 4B, confirms the previous observations at higher magnification. The surface is irregular and rough with large crater-like areas, with sharp edges that result of plastic deformation and material tearing. Micro-holes (pit-like surface topography) are present in those craters, which are characteristic of the acid etching surface treatment (Fig. 4C and D). Embedded particles with different sizes and shapes are scattered randomly all over the surface. Note that the implants usually undergo a cleaning procedure after the grit-blasting process, so that the observed particles survived the treatment, implying a firm bonding to the substrate. Fig. 4C and D shows that these particles, marked by red arrows, are attached to the crater like morphology that they have created. Fine small cracks $15\text{--}25\ \mu\text{m}$ long (yellow arrows), which were generated in the vicinity of the particles, are observed.

Fig. 4 – SEM macrograph of the tested commercial implants. A: Implant threads macrograph B: implant surface macrograph – the macrograph is a magnification of the area marked by a blue square on A. C and D: Embedded particle (red arrow) in a crater like area (red circle) with small cracks (yellow arrow) on the implant surface. (For interpretation of the references to color in this figure legend, the reader is referred to the web version of this article).

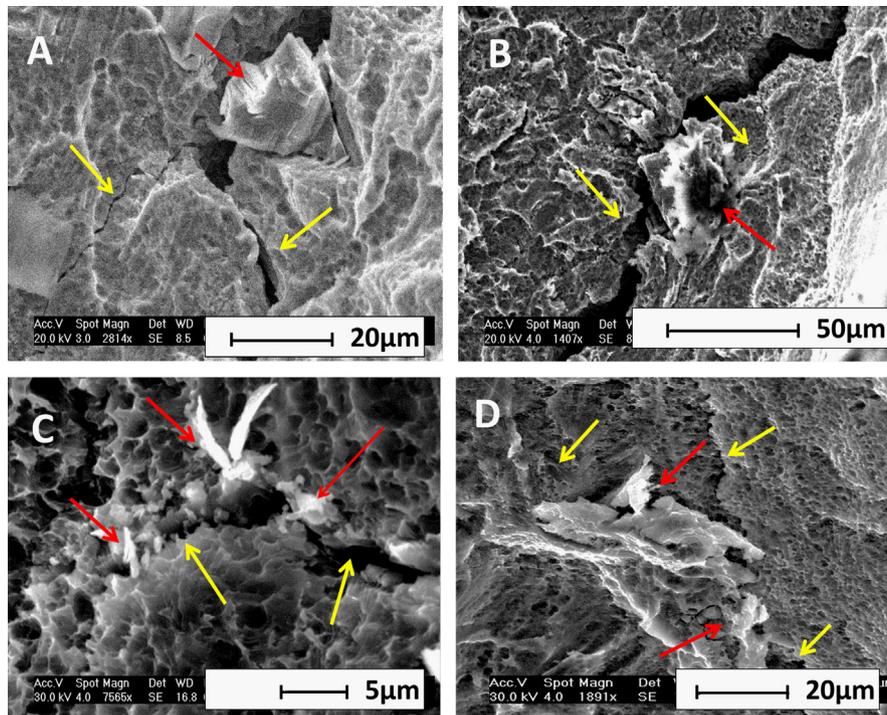
Fig. 5 is a SEM surface micrograph of cracks observed on specimen #3 after 3 check-points (15,000 cycles) before the final fracture. Such micrographs are representative of all the tested

specimens. In all cases, a large main crack was identified. The crack was located between the second and third threads of the implant. Fig. 5A–D shows details of that crack. Lateral secondary cracks, branched from the large main crack, can be identified (Fig. 5 yellow arrows). In addition, Fig. 5A D shows that large and small embedded particles (red arrows) are located along the cracks paths, and probably dictated it.

Fig. 5 – A–D: SEM micrograph of crack identification on fatigue tested specimen 3 before the final failure. On each micrograph the large main cracks and lateral secondary cracks can be identified (yellow arrows) embedded along the cracks are ceramic particles (red arrows). (For interpretation of the references to color in this figure legend, the reader is referred to the web version of this article).

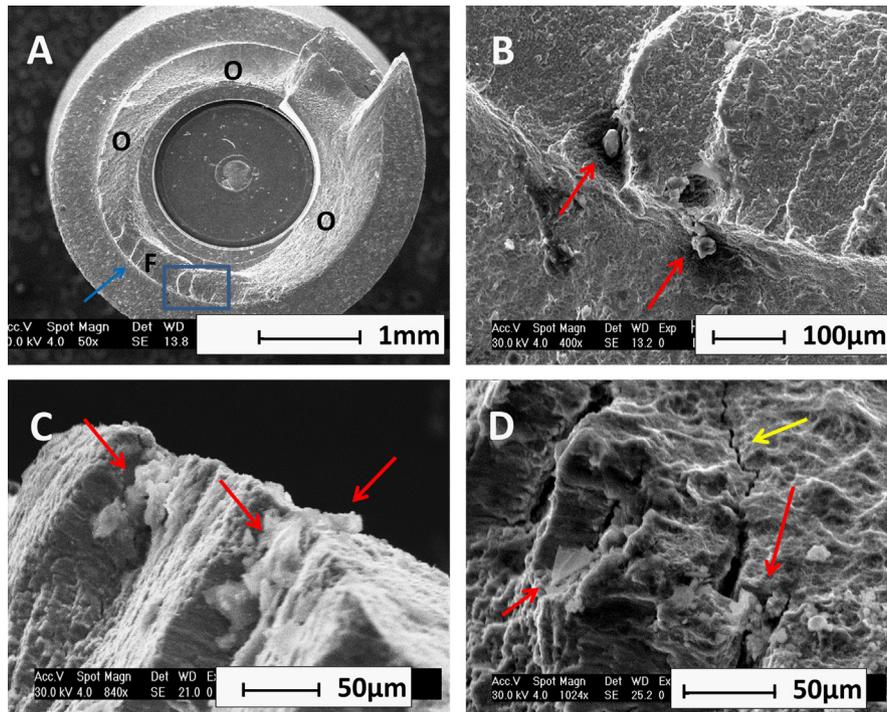
Next, we examined the fracture surface of specimen #3 after final fracture. Two regions can be identified. The main region is rough with sharp edges that fill about 90% of the fracture surface (Fig. 6A letter O). This region correspond the ductile overload failure, with dimples (Kerlins and Phillips, 1987) at magnification of 1K (not shown in the figure). The second region is flat and fills only 10% of the fracture surface (Fig. 6A letter F). This region corresponds to the fatigue failure process with its classical striations (Kerlins and Phillips, 1987), at magnification of 7K (not shown in the figure). The fatigue crack initiation site is marked by blue arrow on the fractograph, as identified from the array of steps (outlined by a

Fig. 6 – Fracture surface of fatigue tested implant after final fracture. **A:** The fracture surface with flat part caused by fatigue failure mechanism marked by the letter “F” with crack initiation location (Blue arrow) and rough part marked by the letter “O” **B:** Upper view of crack initiation location – the macrograph is an enlargement of the area marked by a blue square on A with embedded particles marked by red arrows **C:** Side view of crack initiation location with embedded particles marked by red arrows. **D:** Side view: secondary cracks, marked by yellow arrows, on the lateral view, at the vicinity of the fracture surface with embedded particles along the crack, marked by red arrow. (For interpretation of the references to color in this figure legend, the reader is referred to the web version of this article).

rectangle in Fig. 6A). This region is magnified in Fig. 6B. The presence of foreign particles (red arrows) embedded in, or close to the steps is clearly visible.

Looking at the outer face of each staircase from the surface side (side view), shows again embedded particles (Fig. 6C red arrows). All the above fractographic evidence suggests that the ceramic particles are related to the cracks nucleation sites, leading to final fracture. Lateral secondary cracks can be identified on side views of the implant surface, near the outer face of the fracture surface, (Fig. 6D yellow arrows) with embedded particles (Fig. 6D red arrows).

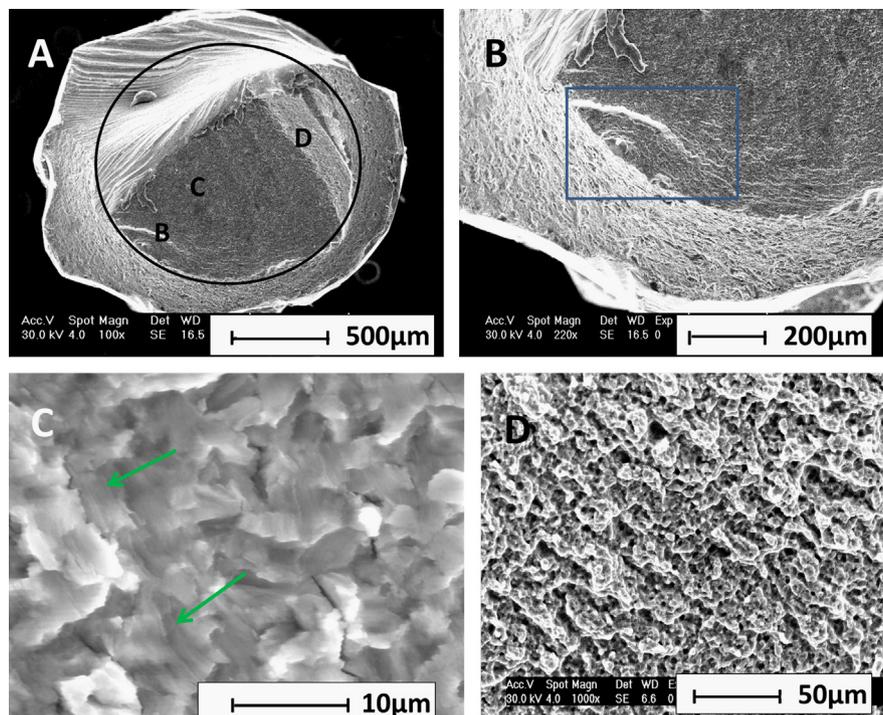
Fig. 7 (Ti-6Al-4V) and 8 (CP-Ti) show typical fractographs obtained during the failure analysis that was carried out in order to identify the failure mechanism(s). The fracture surfaces are all outlined by a circle. The fracture surface can be divided into two regions, as was observed for the laboratory specimens. The main part is flat and unified in appearance and occupies roughly 90% of the fracture surface. The second region is rough with sharp edges over the remaining 10% of the fracture surface. The operating failure mechanism in the first region is identified as (ductile) monotonic overload, as evidenced from the dimples observed in this region (Figs. 7D and 8D).

On the fracture surface of retrieved fractured CP-Ti and Ti-6Al-4V dental implants, parallel lines were identified and marked by the letter B in Figs. 7A and 8A. Those parallel lines

can be seen at higher magnification in Figs. 7B and 8B. Such lines are identical in nature to those identified on the fracture surfaces of the laboratory fatigue tested implants (Fig. 6A and B). Consequently, those features point to the origin of the fatigue crack, i.e. the onset of the implant's failure process (Figs. 7B and 8B). In this case too, the lines originate from the free surface of the implants.

Fractographic examination of the flat region, for every examined retrieved dental implant, clearly reveals the operation of a *fatigue fracture mechanism*. Faint fatigue striations (Kerlins and Phillips, 1987; Shemtov-Yona et al., 2014b) are observed on the retrieved Ti-6Al-4V dental implants when high magnification of 10K is used (Fig. 7C green arrow). These fatigue striations were identical to the fatigue markings seen on the specimen fractured in lab conditions. Likewise, clear fatigue striations are visible on the retrieved CP-Ti dental implants when a magnification of 6K or more is used (Fig. 8C, green arrow).

The rough part of the fracture surface marked by the letter D on Figs. 7A and 8A is characteristic of monotonic ductile overload failure (Kerlins and Phillips, 1987).

Fig. 7 – Failure analysis of retrieved fractured Ti-6Al-4V dental implants with representative fractographs A: The fracture surface marked by round circle. The letters on the fracture surface are the locations on the fracture surface of fractographs B, C and D. B: fractograph of crack initiation location (Blue square) (X220). C: fractograph of fatigue crack propagation: fatigue striations are marked by green arrows (8 K) on the flat part. D: final failure markings, dimples on the rough part. (For interpretation of the references to color in this figure legend, the reader is referred to the web version of this article).

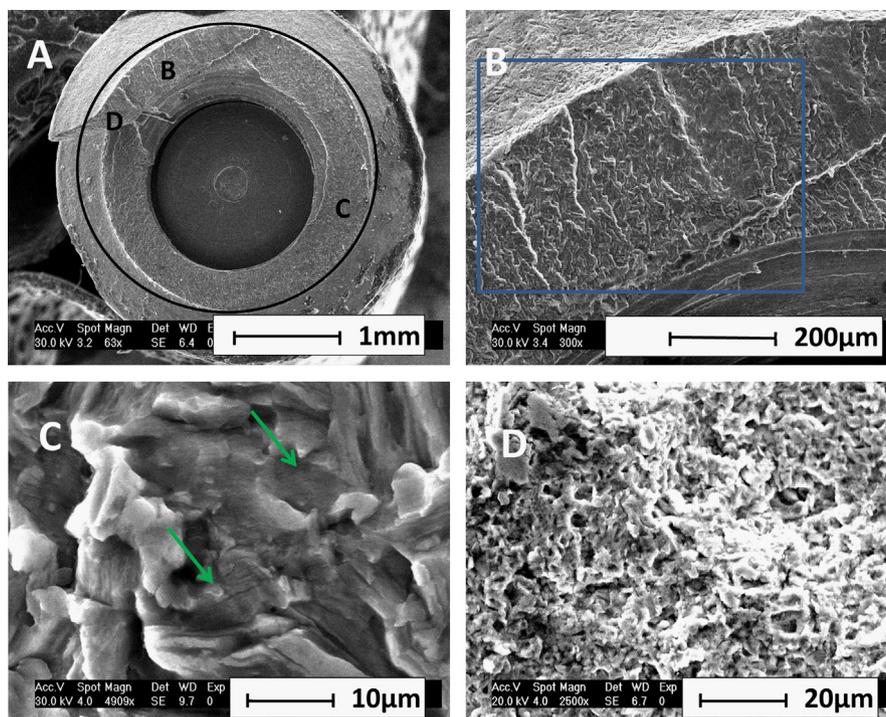
Fig. 8 – Failure analysis of retrieved fractured CP-Ti dental implants with representative fractographs A: The fracture surface marked by round circle. The letters on the fracture surface are the locations on the fracture surface of fractographs B, C, and D. B: fractograph of crack initiation location. Parallel line marked by a blue square on the flat part. C: fractograph of fatigue crack propagation: fatigue striations are marked by green arrows on the flat part. D: final failure markings, dimples on the rough part. (For interpretation of the references to color in this figure legend, the reader is referred to the web version of this article).

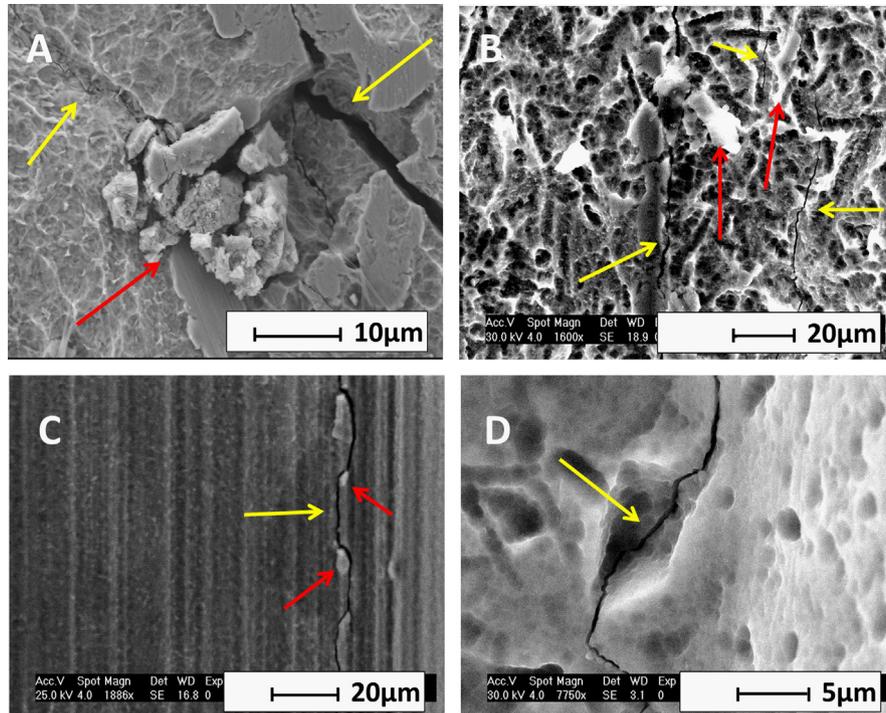
Ti-6Al-4V (Fig. 9 A and B) and CP-Ti (Fig. 9C and D). These micrographs are taken from the threaded part of the implant's body.

SEM micrographs of the secondary cracks in several retrieved Ti-6Al-4V and CP-Ti implants, show embedded foreign particles (Fig. 9 red arrows). EDX analysis of the embedded particles on the path of the secondary cracks reveals that these particles are made of Al_2O_3 and/or FeO. Judging from the overall secondary crack path, it appears that the embedded particles affect the secondary crack path itself.

Fig. 9 – surface micrographs A and B: micrograph from Ti-6Al-4V implant's surface that were grit blasted and acid etched with secondary cracks (yellow arrow) with embedded ceramic particles along the secondary cracks path (red arrow). C: micrograph from machined implant surface with secondary cracks (yellow arrow) with embedded particles caused by machining. D: micrograph from implant surface with secondary cracks (yellow arrow) with deep craters generated by the surface treatment. The secondary crack passes through the deep crater. (For interpretation of the references to color in this figure legend, the reader is referred to the web version of this article).

Considering the nature of the imparted damage, SEM observations clearly showed the presence of embedded ceramic particles on the implants' surface. During the fabrication process of the implants these particles should be removed either by chemical treatments done according to the ISO recommendations (ISO B600, 2007; ISO F86, 2007), or during the etching surface treatments done using a strong acid. The very fact that these particles remained embedded to the surface, whether intact or shattered indicates that these particles have adhered to the surface as a result of the aggressive surface treatment. In that case too, the numerical simulations show that for a certain velocity, the surface temperature can approach or even exceed the melting temperature of the surface, thereby apparently promoting a strong particle-substrate adhesion process.
