Fractographic characterization of fatigued zirconia dental implants tested in room air and saline solution

K. Shemtov-Yona^{a,*}, M. Özcan^b, D. Rittel^a

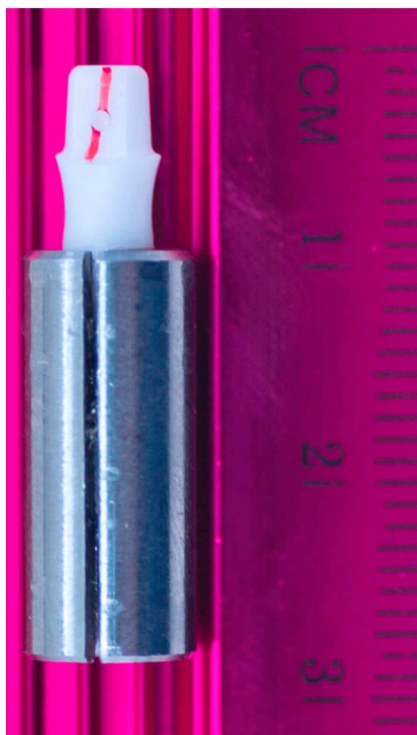
Fig. 1. Ceramic dental implant mounted in the cylindrical steel jacket. The red marker line indicates the side to be bent during loading. (For interpretation of the references to colour in this figure legend, the reader is referred to the web version of this article.)

Commercial dental implants, made of Y-TZP ceramic (composition listed in Table A1, Appendix 1) were cemented in steel cylindrical jackets (Fig. 1). The specimens were then loaded at an angle of 30° (as recommended in [28]) with respect to the vertical axis of an MTS servo-hydraulic machine operated in displacement control for the monotonic overload tests and in load control for random spectrum fatigue testing. All the tested specimens were mounted identically and had their first thread exposed out of the jacket.

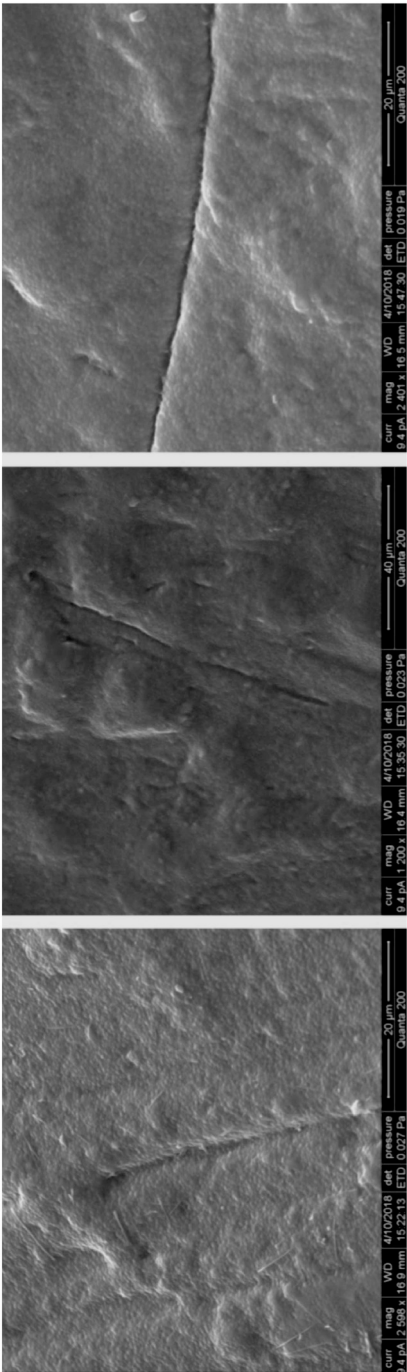
[Fig. 2](#) shows low magnification pictures of the (outer) surface of various implants. One can notice the present of several crack-like flaws, whose origin may be related to the manufacturing and/or handling of the implant. Such flaws can act as native stress raisers, adding to the statistical dispersion of the fatigue performance of the implants.

Fig. 2. Surface morphology of various implants (fractography not reported here).

The first observation that comes out of the results is that whatever the loading mode and the atmosphere, the identification of the fracture origin is rather straightforward, and a potential source for cracking initiation may be related to the presence of microscopic surface scratches or other geometrical flaws.

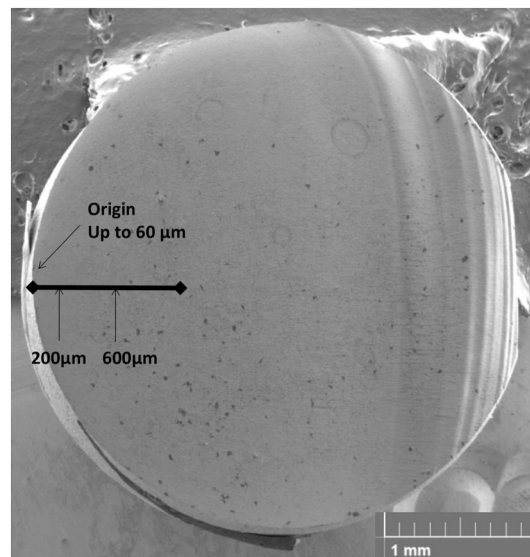
[Fig. 3](#) is a macroscopic picture of a typical fracture surface. One can see the surface is relatively flat. The crack origin is marked (approximately 59 μm , see appendix) with the addition of 200 μm and 600 μm locations. The fractographs shown in sequel were taken from the marked generic locations.

Fig. 3. Macroscopic fracture surface with typical observation distances from the implant's outer surface.

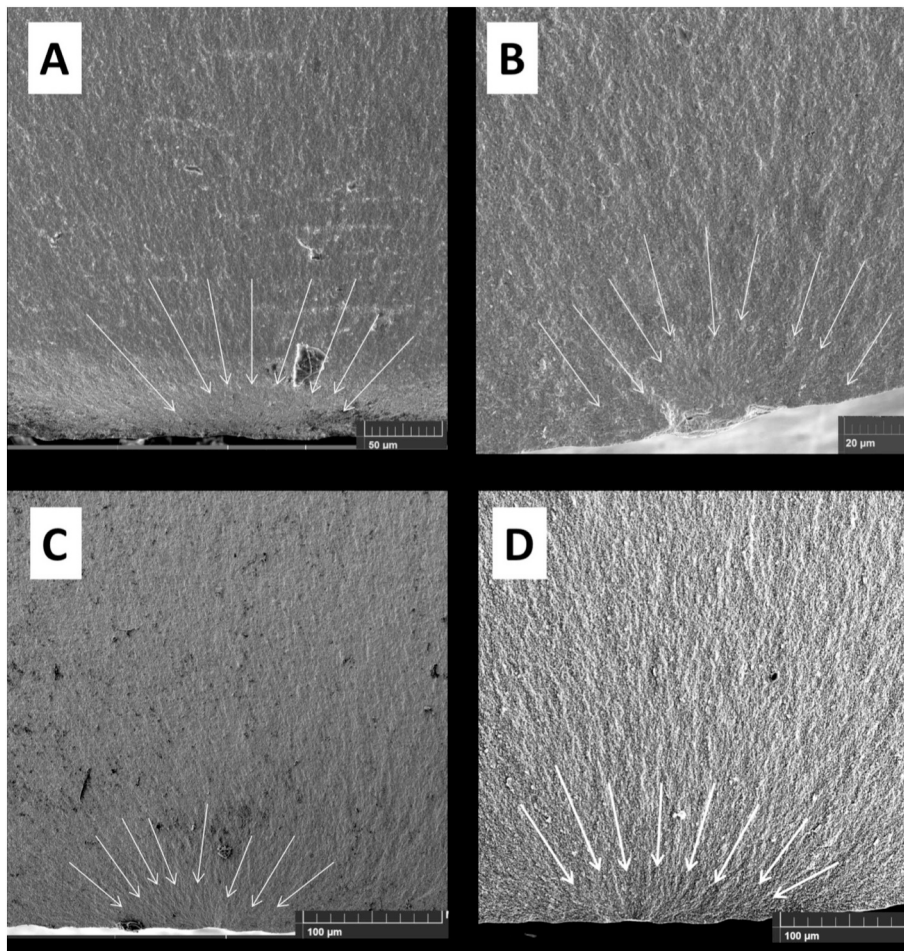
The origin of the fractures of selected implants is shown in [Fig. 4](#). The field of view is relatively large, roughly $200 \times 100 \mu\text{m}$. Irrespective of the loading mode and atmosphere, this origin is clearly identified on each picture and outlined by river lines that point to the origin, as typical for brittle materials.

Fig. 4. Macroscopic origin. A: C3 static-dry, B: C36-static saline, C: C16-spectrum dry, and D: C45-spectrum saline. The arrows indicate hackles pointing to the crack origin.

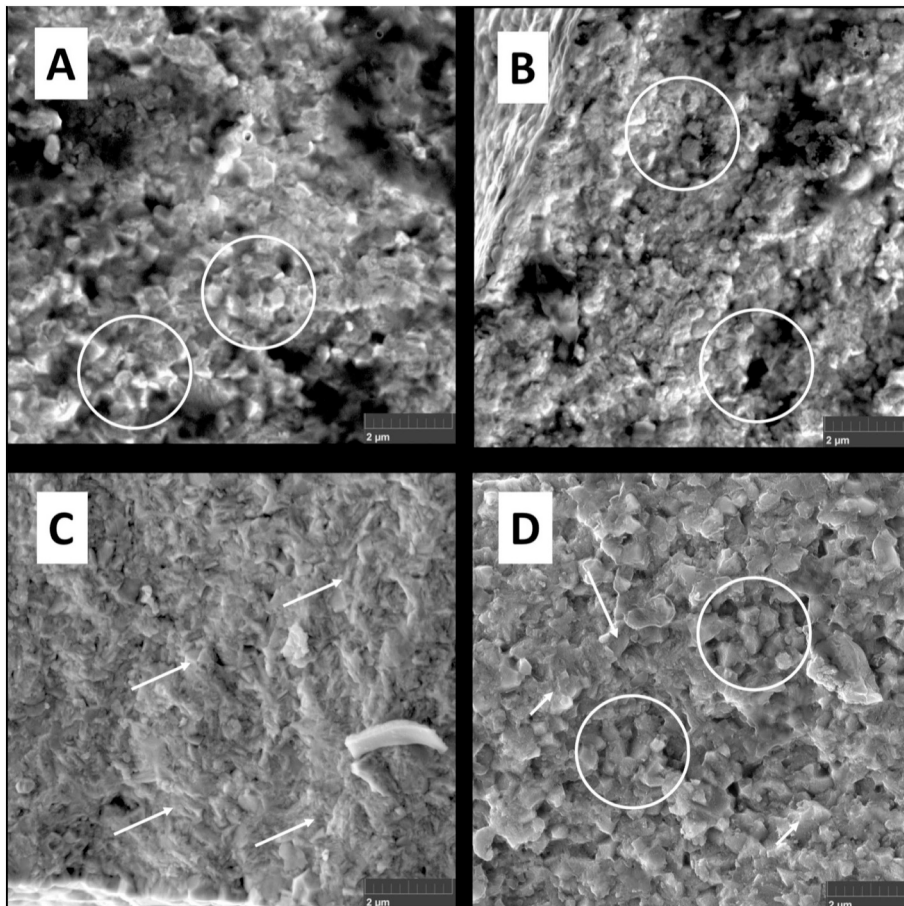
Additional information can be retrieved by examination of the crack's origin at higher magnifications, as shown in [Fig. 5](#).

In the origin region, both room-air and saline solution, statically broken specimens exhibit dominantly transgranular with some intergranular fracture, evidenced by cavities (pulled-out grains indicated by white circles), as shown in [Fig. 5 A](#) and [B](#). For the fatigue specimens, the topography of the fracture surface of the room-air specimen is essentially transgranular, ([Fig. 5 C](#)), while for the saline one, it is a mixture of inter. and transgranular fracture, ([Fig. 5 D](#)).

Fig. 5. Fracture origin. A: C1-static dry, B: C38 static-saline, C: C16-spectrum dry, and D: C51 spectrum saline. The circles indicate intergranular and the arrows transgranular fracture.

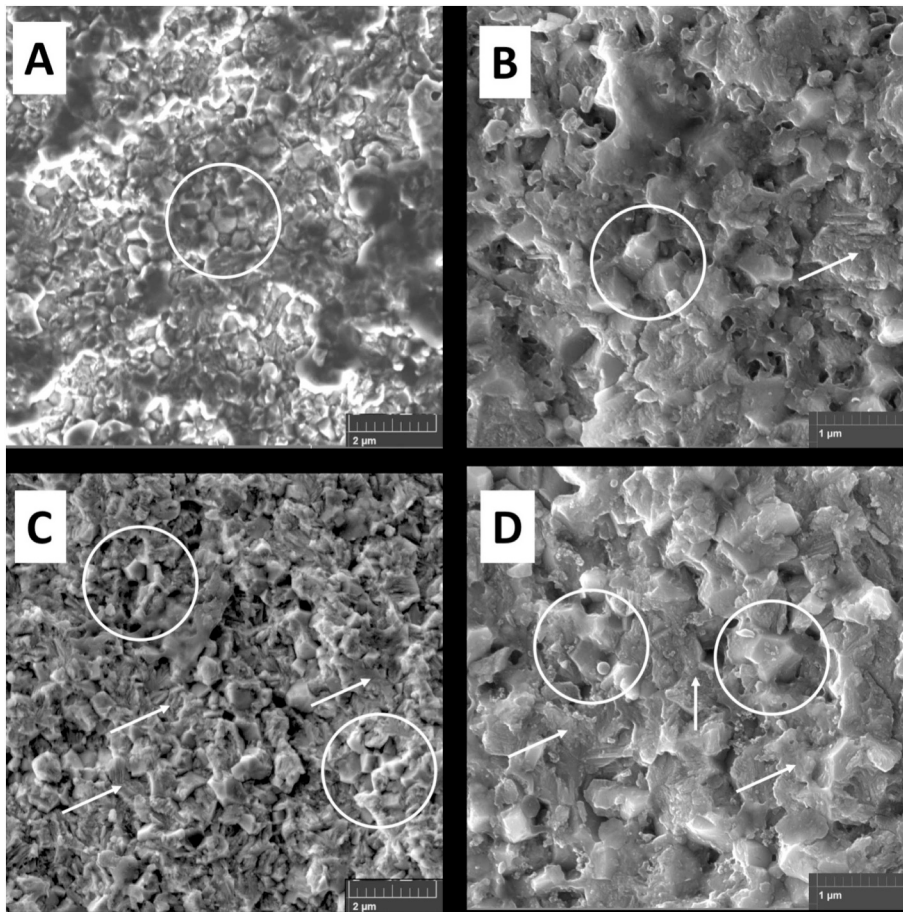
Examination of the fracture surface at about 200 μm from the specimen's edge reveals details about the onset of unstable crack propagation outside the origin area ([Fig. 6](#)).

Here too, both room-air and saline solution, statically broken specimens exhibit a mixed mode of inter. and transgranular fracture ([Fig. 6 A](#) and [B](#)). The same observation applies to the spectrum loaded specimens ([Fig. 6 C](#) and [D](#)).

Fig. 6. Fracture surface at about 200 μm away from the fracture origin (implant's edge). A: C1-static dry, B: C36-static saline, C: C16-spectrum dry, and D: C39-spectrum saline. The circles indicate intergranular and the arrows transgranular fracture.

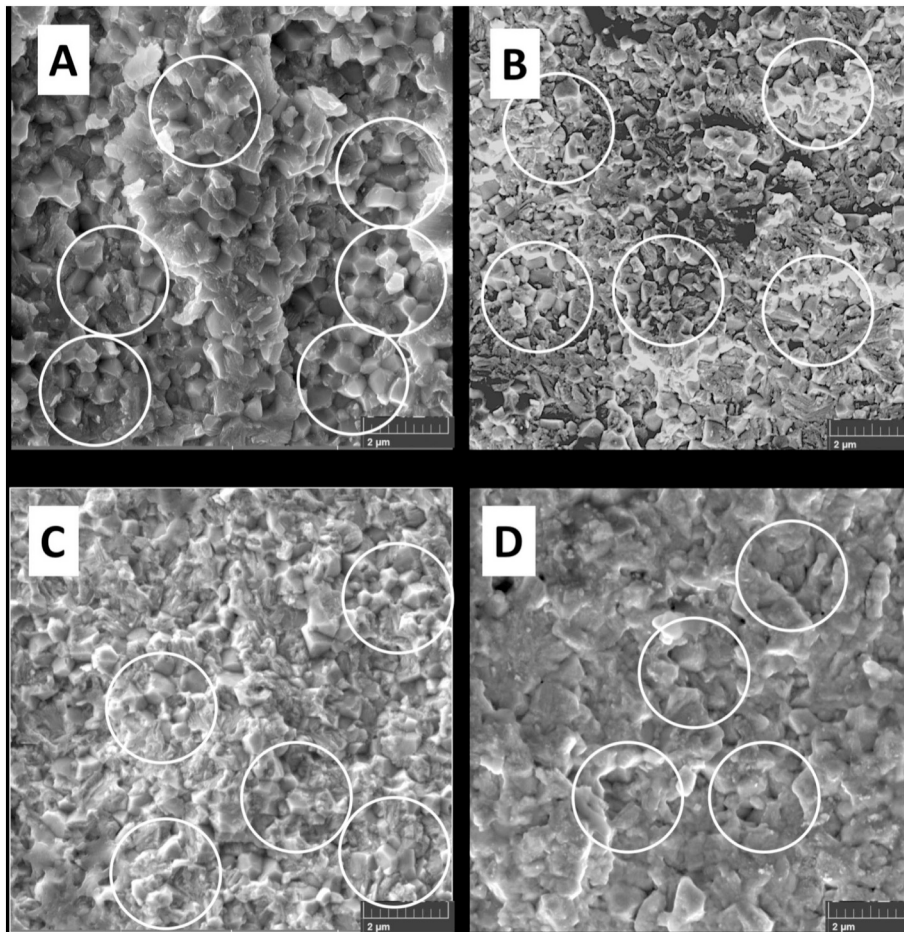
[Fig. 7](#) shows the typical topography of the fracture surfaces of fully developed and unstable cracks.

Both room-air and saline solution, statically broken specimens, exhibit dominantly intergranular fracture with interspersed transgranular ([Fig. 7 A](#) and [B](#)). The same applies to the spectrum-loaded specimen tested in room air ([Fig. 7 C](#)), while that tested in saline solution is dominantly intergranular with minimal presence of transgranular ([Fig. 7 D](#)).

Fig. 7. Fracture surface at about 600 μm or more from the fracture origin (implant's edge). A: C3-static dry, B: C38-static saline, C: C16-spectrum dry, and D: C51-spectrum saline. The circles indicate intergranular fracture.

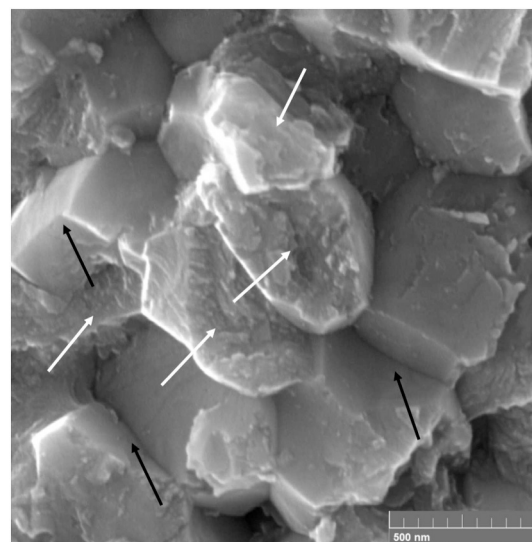
[Fig. 8](#) shows a high magnification of the fracture surface, aimed at illustrating intergranular and transgranular fracture.

Fig. 8. Intergranular (black arrows) and transgranular (white arrows) fracture.

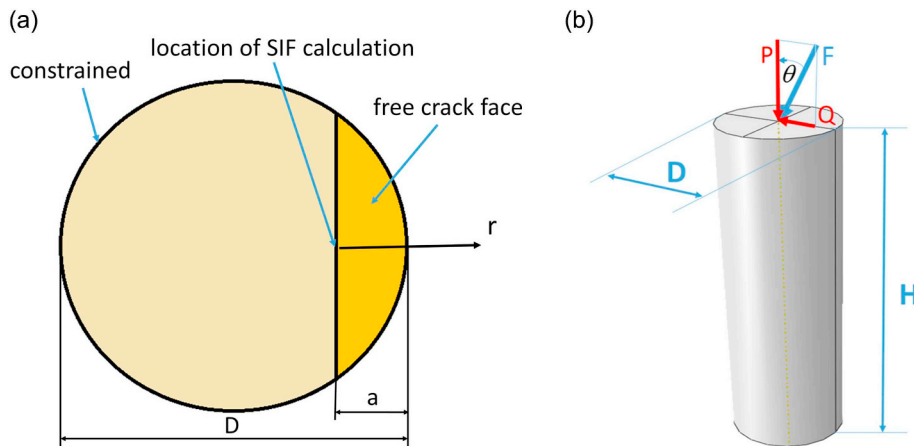
We consider a cylindrical pole, 12.5 mm high and 3.5 mm in diameter. The pole contains a basal crack (at $h = 0$) whose upper face is traction free, bottom face is constrained and the lower ligament is assumed to be fully constrained. On the top of the pole, a 100 N load is applied at a 30° angle. The stress intensity factor (SIF) is calculated at the middle of the crack tip line (Fig. A1a) where it is assumed that plane-strain conditions prevail (Fig. A1).

Fig. A1. Model for calculation of the stress intensity factor of a basal crack in a cylindrical ceramic pole under bending loads. a: Bottom half-constrained crack, and b: The loaded pole, representing a dental implant is made of Zirconia with a Young's modulus $E = 200$ GPa and Poisson's ratio $\nu = 0.31$.

In which the various variables are shown in Fig. A1, and Y is the crack shape factor, $f(a/D)$.

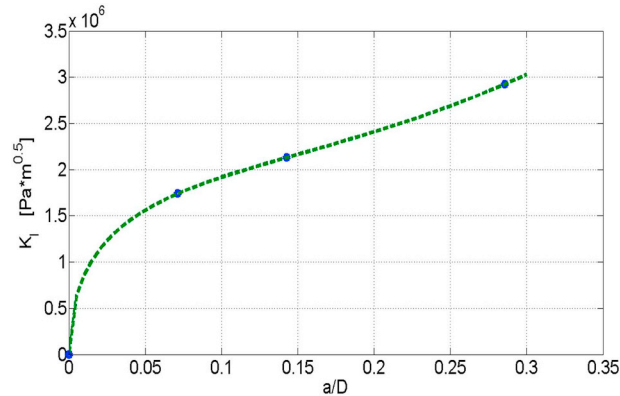
Fig. A2 shows the calculated dependence of the stress intensity factor upon the crack's relative depth. The SIF is calculated from the upper crack face displacement along the coordinate r (Fig. A1a) by fitting the numerical normal gaps to the expression [34]:

Fig. A2. Stress intensity factor versus a/D .

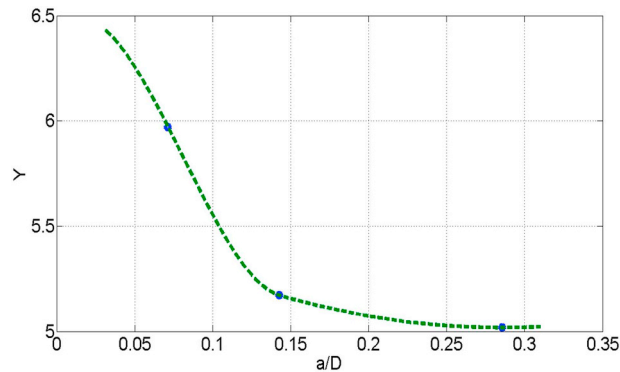
Fig. A3. The non-dimensional crack shape factor Y versus a/D .

For short cracks, Fig. A3 shows that $Y \approx 6.5$. Assuming that K_{Ic} is $5.5 \text{ MPa m}^{1/2}$, and substituting a typical value of the fracture load $F = 600 \text{ N}$ in Eq. (A1), one obtains the following estimation for a short crack: $a(Y = 6.5) = 59 \mu\text{m}$.
