Microstructural aspects of adiabatic shear failure in annealed Ti6Al4V

P. Landau¹, A. Venkert² and D. Rittel^{3*}

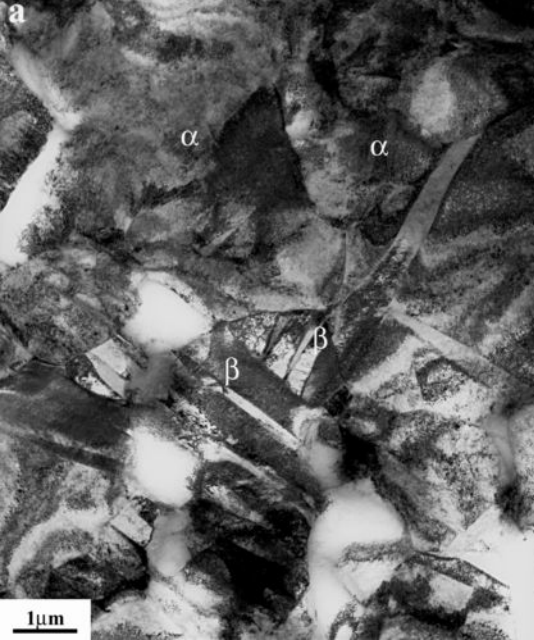
- Figure 4: Interrupted dynamic sample – TEM micrographs far away from the shear concentration area: (a) The typical microstructure consists of dislocation cells in the α phase and a higher density of stress induced martensite in the β phase, both denoted on the micrograph. (b) Area showing stress- induced (α') martensite (arrowed) transformed from the β phase, and its corresponding SADP.

Away from the potential fracture plane ($\sim 50\mu\text{m}$), the microstructure consists of dislocation cells in the α phase (Figure 4a). The cell size is approximately $2\mu\text{m}$, similar to the cell size observed in the interrupted static samples (compare Figure 4a with Figure 3a). Closer to the potential fracture plane (about $10\text{--}20\mu\text{m}$), the cell walls become sharper, indicating that the dislocation density in the boundaries is higher, and the misorientation angle between adjacent cells is larger than before. The density of martensitic platelets was observed to increase gradually as one gets closer to the shear concentration area (potential fracture plane). In addition, the density of martensitic platelets in the β phase is sensibly higher in the interrupted dynamic samples than in the interrupted static ones (compare Figure 4a with Figure 3a).

As a general remark, note that two types of martensite were observed in the specimens, irrespective of the strain rate. For example: the martensite in Figure 4b is of the α' (hcp) type, which is also stress induced from the β phase, as was the α'' (orthorhombic, Figure 3b).

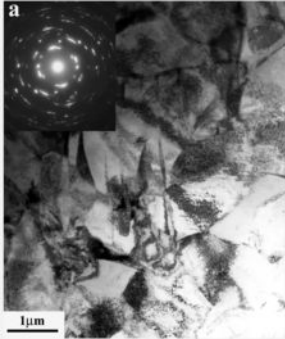
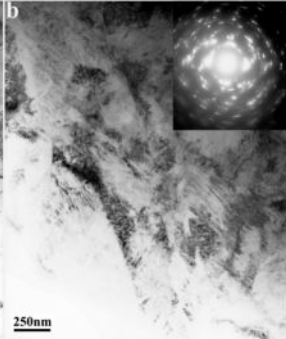
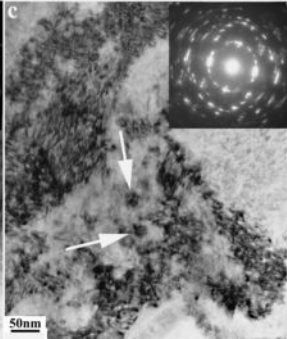
- Figure 7: Dynamically failed specimen - TEM-micrographs. (a) Far from the ASB: Dislocation cells and stress-induced martensite. The typical SADP mainly contains misoriented α phase cells. (b) Within the ASB: High dislocation density without any distinct morphology. The SADP shows incomplete rings indicating the presence of very fine recrystallized grains. (c) Higher magnification of (b): The high dislocation density screens the fine grains revealed by the SADP. A few DRX nanograins are arrowed in the micrograph. Note the similarity of morphologies between Figures (6) and (7c), namely high dislocation density and the presence of very fine recrystallized grains (Reprinted from [17]).

The evolution of the microstructure in these samples is overall quite similar to the evolution observed in the interrupted dynamic samples. As the field of view is moved closer to the fracture plane, the microstructure changes gradually from dislocation cells (small misorientation angles between adjacent cells), into subgrains (higher misorientation angles between subgrains) manifested in the SADP as spotty ring patterns. Figure 7a shows the typical microstructure observed in this region, consisting of misoriented subgrains in the α phase and a high density of stress induced martensite in the β phase. In the core of the fracture plane (shear localization area - Figure 7b), a region comprised of avalanched dislocation cells (high density dislocations) is observed, characterized by incomplete rings in the SADP. Dynamically recrystallized nanograins, with a low dislocation density, 10-50nm in diameter, are again observed within the avalanched dislocations region. These DRX nanograins are discernable at higher magnifications as can be seen in Figure 7c (arrowed). Note that a similar evolution was reported by Xue et al. [19-20] for 316L-SS.

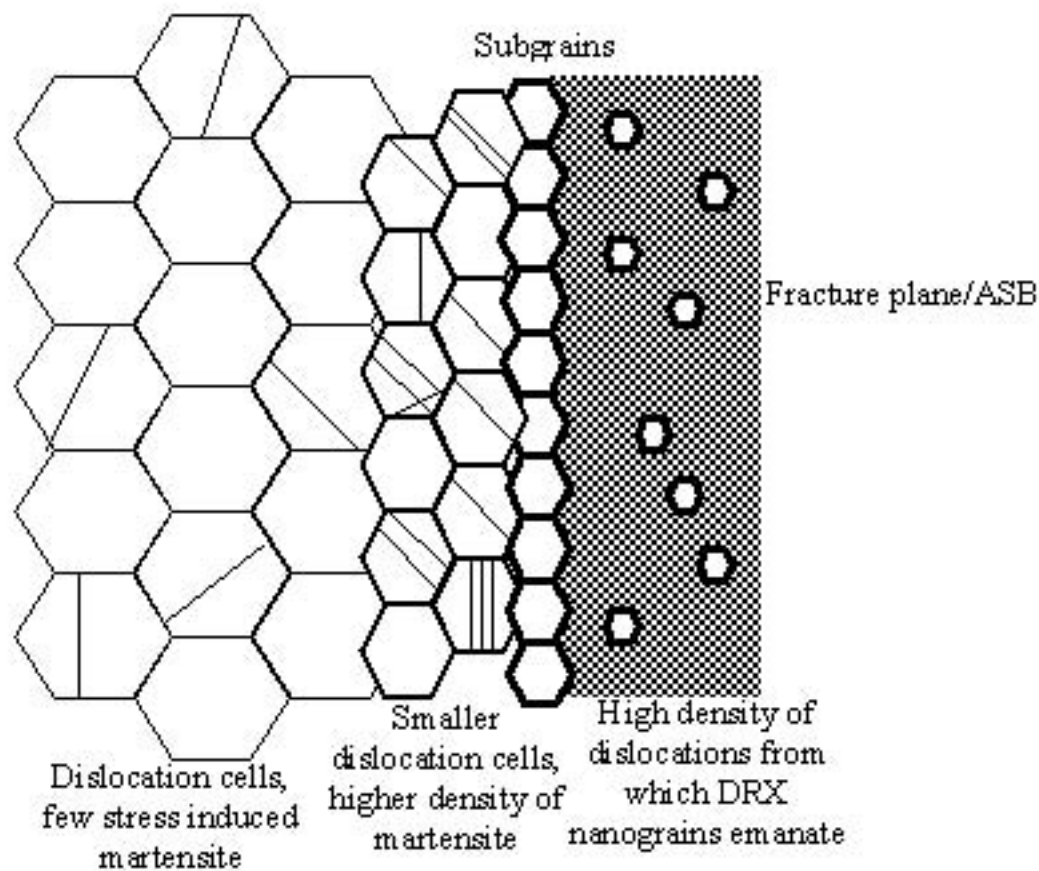
- Figure 8: A schematic representation of the microstructural refinement as a function of the distance from the ASB/ fracture plane. The microstructure evolves from dislocation cells into subgrains and the density of martensite increases with the proximity to the fracture plane. In the fracture plane an avalanched, high dislocation density area is observed, from which DRX nanograins emanate.

The evolution of the microstructure of commercial Ti6Al4V was examined following high strain rate deformation and compared to the static microstructure at a similar strain. The microstructural features observed are presented in a schematic drawing in Figure 8, illustrating microstructural

refinement as the shear localization area is approached, keeping in mind that a large strain gradient is present in this region.
