Research Paper

Mechanical assessment of grit blasting surface treatments of dental implants

K. Shemtov-Yona*, D. Rittel, A. Dorogoy

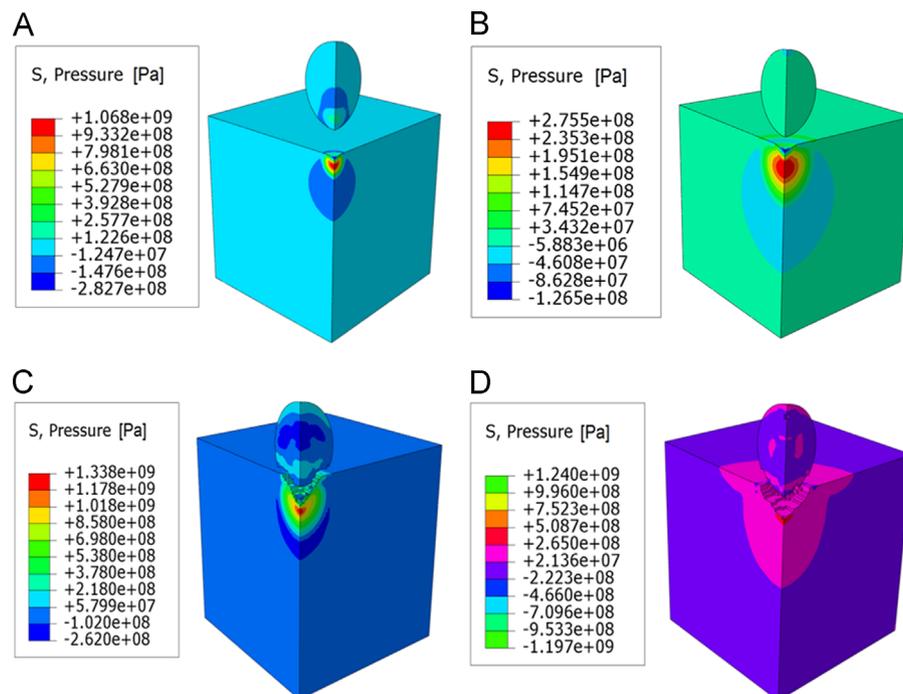
Impact of particles with initial velocities of 50–250 m/s, in steps of 50 m/s, was simulated for the two plate materials, Ti-6Al-4V and CP-Ti grade 1. The residual three-dimensional (3D) pressure distribution ($P = \sigma_{ii}/3$) at $t = 2.5 \mu\text{s}$, i.e. long after the transient impact effects, is shown in Fig. 10. The pressure distribution for the Ti-6Al-4V plate impacted at 50 and 250 m/s is shown in Fig. 10A and C, respectively. The results for the CP-Ti impacted at similar velocities are shown in Fig. 10B and D. A large zone underneath the impact location is subjected to a residual pressure (stress) because of the large plastic deformation of the substrate. A crater is formed underneath the impact location, as shown in Fig. 10A and B, even at the lower impact velocity of 50 m/s for both materials. The dimensions (depth and diameter) of the crater grow with increasing impact velocity. Both materials break and tear for impact velocities higher than 150 m/s, as shown in Fig. 10C and D.

Fig. 10 – Contour maps of residual pressure due to impact. A: Ti-6Al-4V plate at 50 m/s. B: CP-Ti plate at 50 m/s. C: Ti-6Al-4V plate at 250 m/s. D: CP-Ti plate at 250 m/s. Note that the region of positive residual pressure (compression) is much larger for the CP-Ti for both impact velocities.

with the impact velocity. At velocities higher than the V_{th} , the materials break and tear.

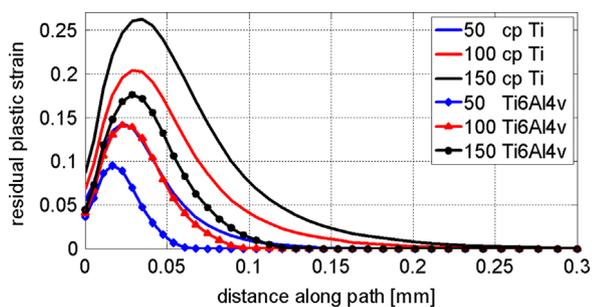
The residual equivalent plastic strain distribution along a vertical path is shown in Fig. 11 for impact velocities of 50, 100 and 150 m/s. The path starts at impact location and stretches to the bottom of the plate (Fig. 3A). The velocities affect the size of the region in which plastic residual strains exist and the strain distribution (shape and magnitude) within this region. A first characteristic parameter of the region is its length along the path. A second characteristic parameter, indicating the extent of the residual plastic strain within the region, is its peak value (since the distribution shape is similar for all velocities). It can be observed that the impact velocity has the same effect on the Ti-6Al-4V and the CP-Ti. Increasing the impact velocity causes the plastic region's length (along the path) to increase, and its peak values to grow. The peak value of the residual equivalent plastic strain in CP-Ti is $\sim 50\%$ higher than for the Ti-6Al-4V. The length of the plastic zone of the CP-Ti is ~ 2 times larger. Such residual strains are the essence of hardening surface treatments aimed at improving the fatigue life of a component.

Fig. 11 – Residual equivalent plastic strain distribution along a vertical path (shown in Fig. 3A) underneath the impact location for CP-Ti and Ti-6Al-4V impacted at 50, 100 and 150 m/s.

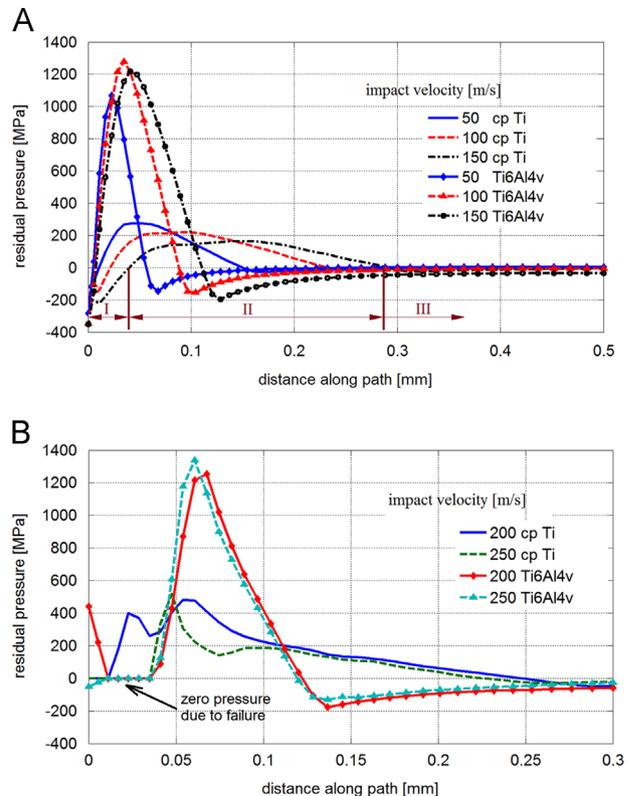
From Fig. 12A, three regions, numbered I to III, can be identified, starting just underneath the impact, as follows:

The regions are outlined for CP-Ti impacted at 150 m/s in Fig. 12A.

For the two materials, as shown in Fig. 12B, the tension region I no longer exists and is replaced instead by a zero

Fig. 12 – Residual pressure distribution along a vertical path (shown in Fig. 3A) underneath the impact location for CP-Ti and Ti-6Al-4V. A: impact at 50, 100 and 150 m/s. B: impact at 200 and 250 m/s.

pressure region. This is due to local fracture (ablation of material) that occurs at impact velocities exceeding 150 m/s.

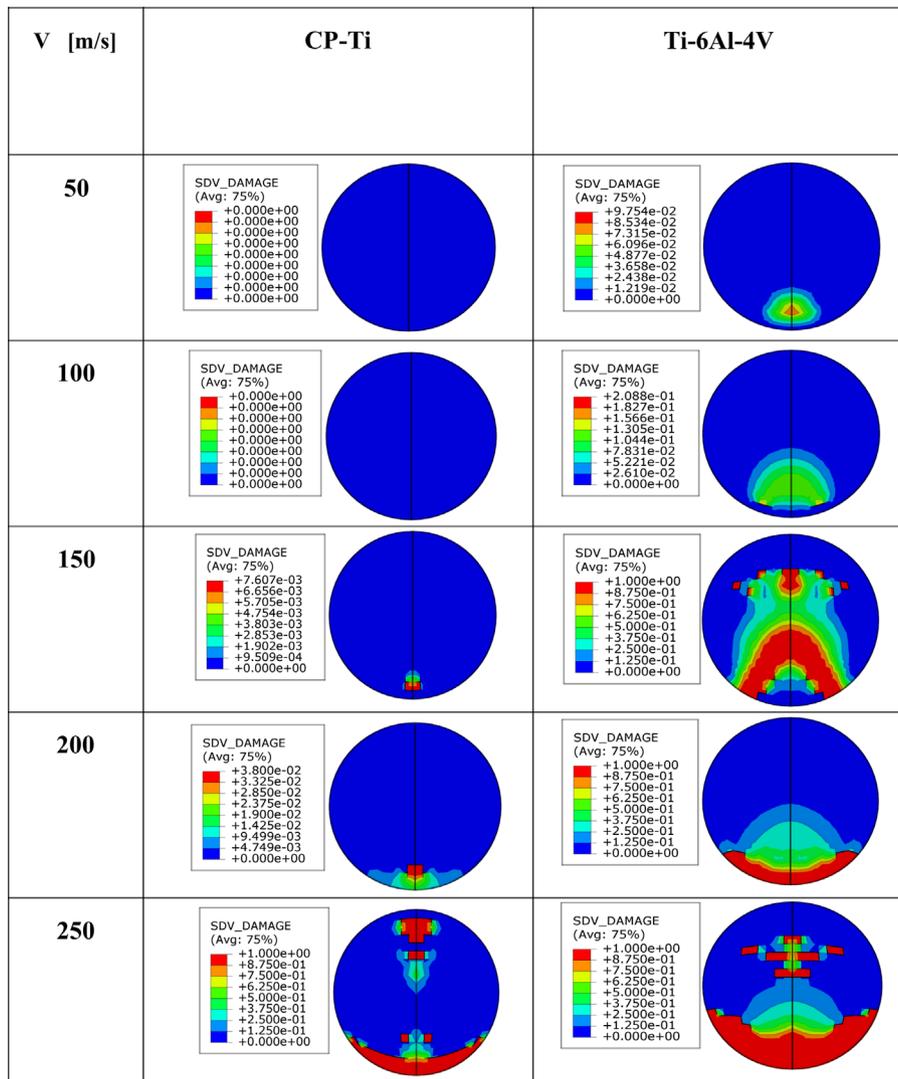
The damage imparted to the ceramic sphere at $2.5 \mu\text{s}$ after impact with the plates at all velocities (50 – 250 m/s) is shown on a mid-section of the sphere in Fig. 13. The damage parameter (SDV_DAMAGE) in the JH2 model lies within 0 and 1 , and quantifies the severity of the damage, from none (0) to total (1).

Fig. 13 shows that the ceramic sphere is already damaged at an impact velocity of 50 m/s when the substrate is made of Ti-6Al-4V, while with CP-Ti, damage starts only at 150 m/s.

Fig. 13 – The damage in ceramic sphere at 2.5 μs after impact with the 2 plates at velocities ranging from 50 to 250 m/s. A value of 0 means no damage, while 1 means total damage.

At 250 m/s the damage is much more widespread for the case of impact with Ti-6Al-4V. This result can be rationalized by noting that Ti-6Al-4V has a much higher hardness than CP-Ti.

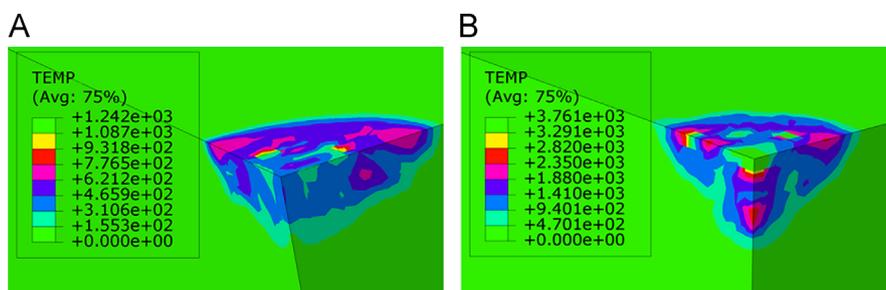
Table 3 shows that for the Ti-6Al-4V substrate impacted at velocities lower than 200 m/s, the temperature rise is moderate. As the impact velocity reaches and exceeds 200 m/s, the temperature rise is significant to an extent that the melting temperature is reached and even exceeded ($T/T_m \geq 1$). The melting phenomenon is likely to cause adhesion of some of the alumina debris to the impacted surface. By contrast, the temperature rise of the CP-Ti substrate is more moderate, but may nevertheless reach ($T/T_m = 0.54$), which is not negligible (Fig. 14).

Fig. 14 – Temperature rise map (in K) for a 250 m/s impact on: A. CP-Ti, B. Ti-6Al-4V.

advised to carefully re-assess the various parameters of a planned grit-blasting treatment, simulate it to optimize it, and validate the process by performing a thorough surface characterization. At this stage, this assessment must be largely experimental.
